# ON FACTORS INFLUENCING GROUND SUBSIDENCE: A CASE STUDY OF MUNROE ISLAND

**ABSTRACT:** Munrothuru (‘Munroe Island’) is a place renowned for continuous settlement, in the Kollam district of Kerala. The Indian Ocean earthquake and Tsunami of 2004 triggered this major problem. The island is located at confluence of the Ashtamudi Lake and the Kallada River. Low lying regions of the island are facing progressive settlement which has become pronounced since the occurrence of Tsunami. The area has been affected by upward seepage of saline water during High Tide events, denoting the axial lowering of land mass. The salinity intrusion of Ashtamudi Lake in island has become recurrent phenomena in the region resulting in several environmental issues. The island is on the verge of sinking and settlement is rapid with time. The foundation on the site has settled and few residents have abandoned their dwelling units. This desk study and walk over survey analyses the geological processes, their risk and damage perceived in past few years. It attempts to improve understanding of changes in island, causes and implications, with comparison to reported land subsidence worldwide. This paper deals wi

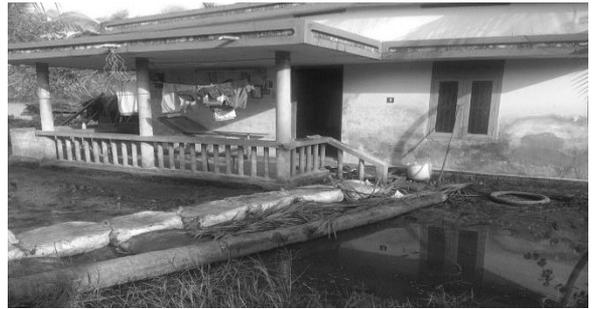
- The residences underwent settlements to the extent that doorsteps sunk into the soil, the walls cracked and openings have separated from the main structure (Fig.2, Fig.3 and Fig. 4). Many occupants have raised the floor level to counter this issue but it resulted in lowered roof level and further settlement due to increase in stresses.

Fig 2 A residential building settled nearly 40cm in Kidaparam South as on 5th Jan 2016. Note that the steps at the entrance have settled into the soft clay.

The settlement of buildings by more than 50cm is reported and has become evident during field inspection. In certain areas, this is apparently due to construction of structures on the clay layer without proper piling in an area where the soil structure consists of top layer of 2 m thick clay. The difference in elevation of these areas compared to the average river water level/backwater level is less than 30cm in most cases. The clay in the area is getting saturated during the semi-diurnal tides as well as due to the capillary rise. It is noted that the construction with heavy concrete structures are settling faster compared to light weight structures.

- Once the highly vulnerable areas are identified rehabilitation measures may be implemented to safely relocate its residents. While designing the new constructions, steps must be taken to keep the stresses to a minimum. This can be achieved by using light weight construction materials.

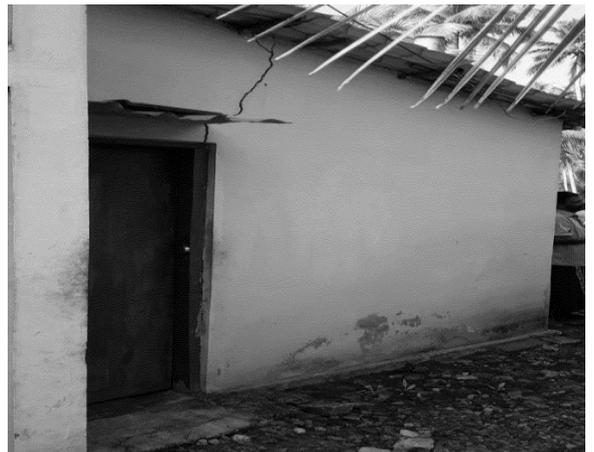
Fig 3 The residential building showing cracks due to differential settlement.
