# ON FACTORS INFLUENCING GROUND SUBSIDENCE: A CASE STUDY OF MUNROE ISLAND

**ABSTRACT:** Munrothuru (‘Munroe Island’) is a place renowned for continuous settlement, in the Kollam district of Kerala. The Indian Ocean earthquake and Tsunami of 2004 triggered this major problem. The island is located at confluence of the Ashtamudi Lake and the Kallada River. Low lying regions of the island are facing progressive settlement which has become pronounced since the occurrence of Tsunami. The area has been affected by upward seepage of saline water during High Tide events, denoting the axial lowering of land mass. The salinity intrusion of Ashtamudi Lake in island has become recurrent phenomena in the region resulting in several environmental issues. The island is on the verge of sinking and settlement is rapid with time. The foundation on the site has settled and few residents have abandoned their dwelling units. This desk study and walk over survey analyses the geological processes, their risk and damage perceived in past few years. It attempts to improve understanding of changes in island, causes and implications, with comparison to reported land subsidence worldwide. This paper deals wi

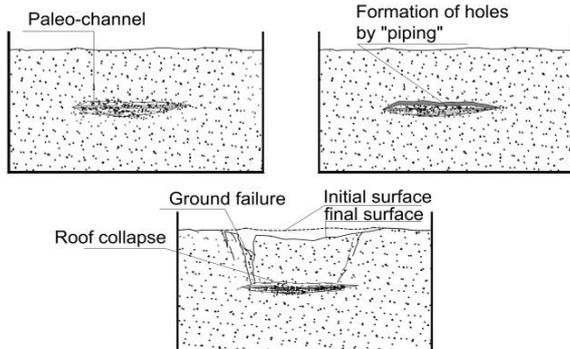
Fig 4 Different stages on the formation of ground failures related to buried paleo-channels. Fine soil in the paleo-channel is carried away by subsurface runoff, causing the formation of voids. Eventually, sediments above the paleo-channel can collapse generating a ground failure. (Jesus et al., 2013)

The origin of this ground failure can also be associated with the dragging of fine sediments in buried paleo-channels, causing the removal of mass and the subsequent formation of large voids, similar to the piping effect described before (Jesus et al., 2013). Paleo channels are former streams that became incised into the underlying material, later became abandoned by shifting of flow patterns and subsequently became filled with alluvium (Fig.4). The presence of such channels can be established by conducting a series of resistivity and gravimetric surveys (Fig.5).

- Electrical Resistivity and Gravimetric surveys may be conducted in order to detect hidden or incipient ground failures. In areas where paleo-channels are identified, grouting or deep cement mixing measures may be undertaken to stabilize the area.

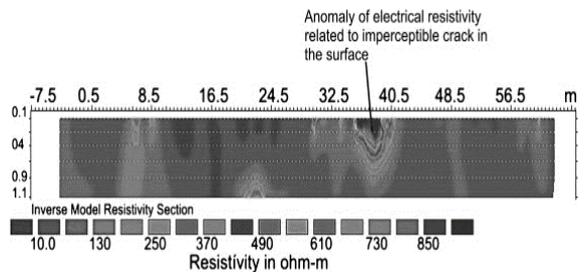
Fig 5 Profile of resistivity used for detecting hidden or incipient ground failures. High values of resistivity (red tones) can be interpreted as discontinuities in the subsoil, whereas the low valued zones (blue tones) as a homogeneous soil (Jesus et al., 2013)
